3D Geological Modelling as a Tool for Evaluating Foundations – A Case Study for Lower Baker Dam, Washington State, USA

Cam Bartsch, M.Sc., P.Geo. & Tony Gilman, M.Sc., P.Geo, P.Eng.
Terrane Geoscience, Halifax, Nova Scotia, Canada

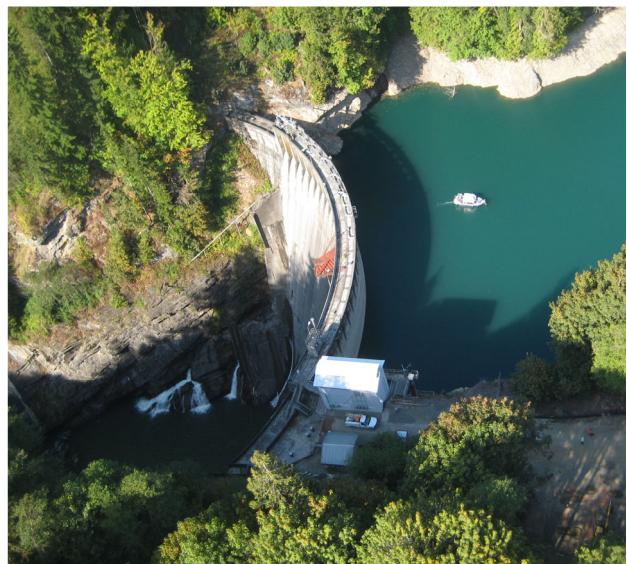
Figure 1. Overhead photo of Lower Baker Dam.

The Lower Baker Dam (LBD) is located at the confluence of the Baker and Skagit Rivers in northwest Washington and forms the Lake Shannon reservoir. The dam is a 285-foot-high concrete arch structure that was constructed in 1925 and is owned and operated by Puget Sound Energy (PSE) (Figure 1). The dam began leaking shortly after the reservoir was filled, with leakage emanating from several discrete locations in the bedrock along the abutment walls above the plunge pool and immediately downstream of the dam (Figure 2). PSE has made several attempts to reduce the leakage, starting with a grouting program in the 1940's; however, the effectiveness of these grout programs has not been permanent, and leakage gradually resumes over time.

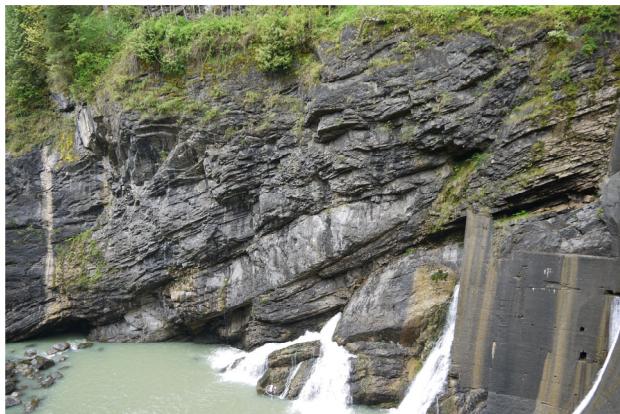
Figure 2. Leakage along structural pathways in the bedrock of the right abutment.

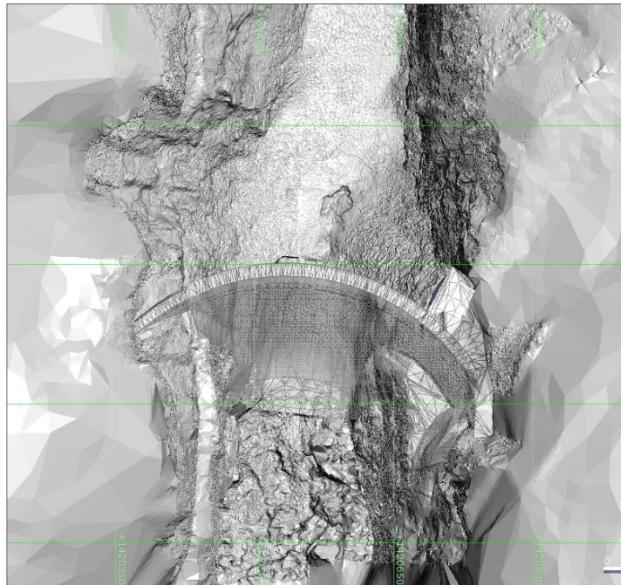
Figure 4. Plan view of LBD showing combined geospatial data (LiDAR and bathymetry). High-resolution DEM surfaces provide detail not achievable with aerial imagery.

The LiDAR and bathymetry point clouds were merged to create a single high DEM that formed the upper boundary of the 3D geological model. The resolution of the DEM was sufficient to identify important geological lineaments as well as carry-out virtual geological mapping of exposed bedrock in both abutments (Figure 4). Mapping from the DEM allowed for the collection of a large amount of accurate structural geology information that would have otherwise been inaccessible due to the near-vertical canyon walls and reservoir.
